Manhole Inspection Summary

Manhole # S09EE1003MH

Insp Date: **9/24/07 3:31 PM**

Location Address: **DORITHAN**

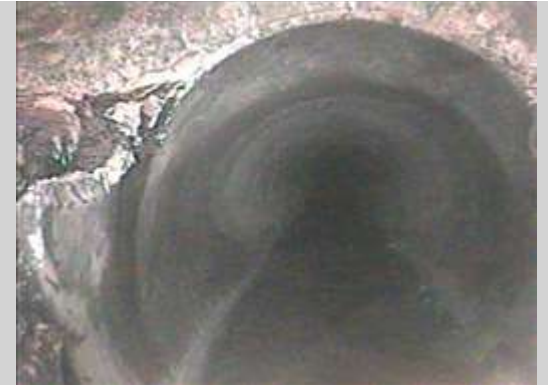
12 O'Clock Outflow

15 in. Circular Gravity Sewer
Pipe Out @ 12 O'Clock

Pipe Height: **13.2** (in.) Rod and Bar
Pipe Material: **Clay** ☐ Pipe Lined
Invert Depth: **9.71** (ft.) Flow Characteristics: **Fast**
Deposits: ☒ None ☐ Mud ☐ Sludge ☐ **Debris** ☐ Grease
Silt Depth: (in.) Deposits Extent:
Infiltration: **None** Pipe Seal Cond: **Sound**

Drop: **None**

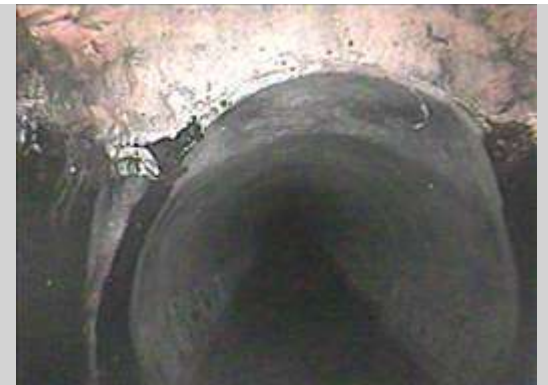
6 O'Clock Inflow

15 in. Circular Gravity Sewer
Pipe In @ 6 O'Clock

Pipe Height: (in.) Direct
Pipe Material: **Clay** ☐ Pipe Lined
Invert Depth: **9.63** (ft.) Flow Characteristics: **Fast**
Deposits: ☒ None ☐ Mud ☐ Sludge ☐ **Debris** ☐ Grease
Silt Depth: (in.) Deposits Extent:
Infiltration: **None** Pipe Seal Cond: **Sound**

Drop: **None**

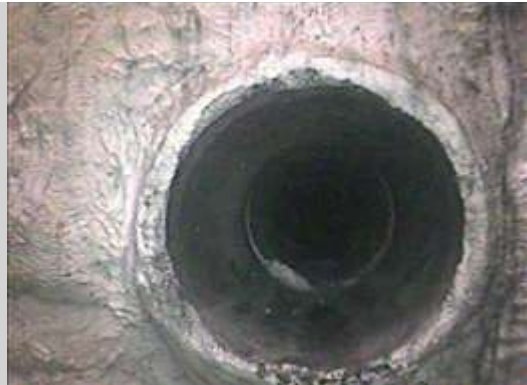
9 O'Clock Inflow

12 in. Circular Gravity Sewer

Pipe In @ 9 O'Clock

Pipe Height: **8.4** (in.) Rod and Bar

Pipe Material: **Clay** ☐ Pipe Lined

Invert Depth: **6.56** (ft.) Flow Characteristics: **Slow**

Deposits: ☐ None ☐ Mud ☐ Sludge ☒ **Debris** ☐ Grease

Silt Depth: **3** (in.) Deposits Extent: **Light**

Infiltration: **None** Pipe Seal Cond: **Sound**

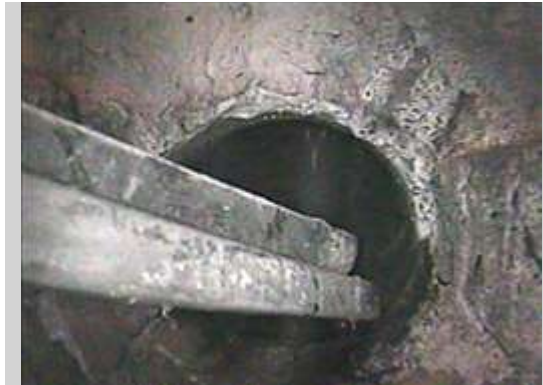
Drop In @ 9 O'Clock

Drop: **Outside Direct**

Inv Depth: **8.92** (ft.)

Drop Condition: **Open**
